Agility, Ability and the Human Side of Surveying When Disaster Strikes

ABSTRACT

Flooding in late February, March and early April of 2022 caused significant damage along large sections of the Australian east coast, in particular locations within the Northern Rivers of NSW. Only days preceding the peak of the first flood event in early March, the NSW State Emergency Service (SES) reached out to NSW Public Works to devise a strategy to engage and brief surveyors for capture of Peak Water Level (PWL) as a priority and Current Water Level (CWL) to a lesser degree for SES flood intelligence, as soon as possible. Several DCS Spatial Services and local private surveyors utilised Global Navigation Satellite System (GNSS) Continuously Operating Reference Station (CORS) Real-Time Kinematic (RTK) across defined areas within the Clarence Valley, Richmond Valley, Lismore and Kyogle Local Government Areas (LGAs) where reliable evidence defined PWL, recording Australian Height Datum (AHD) height, photos, notation of physical evidence and location on SES intelligence maps via the ArcGIS Collector application. A subsequent severe weather event, which hit Byron Shire in late March 2022, required DC

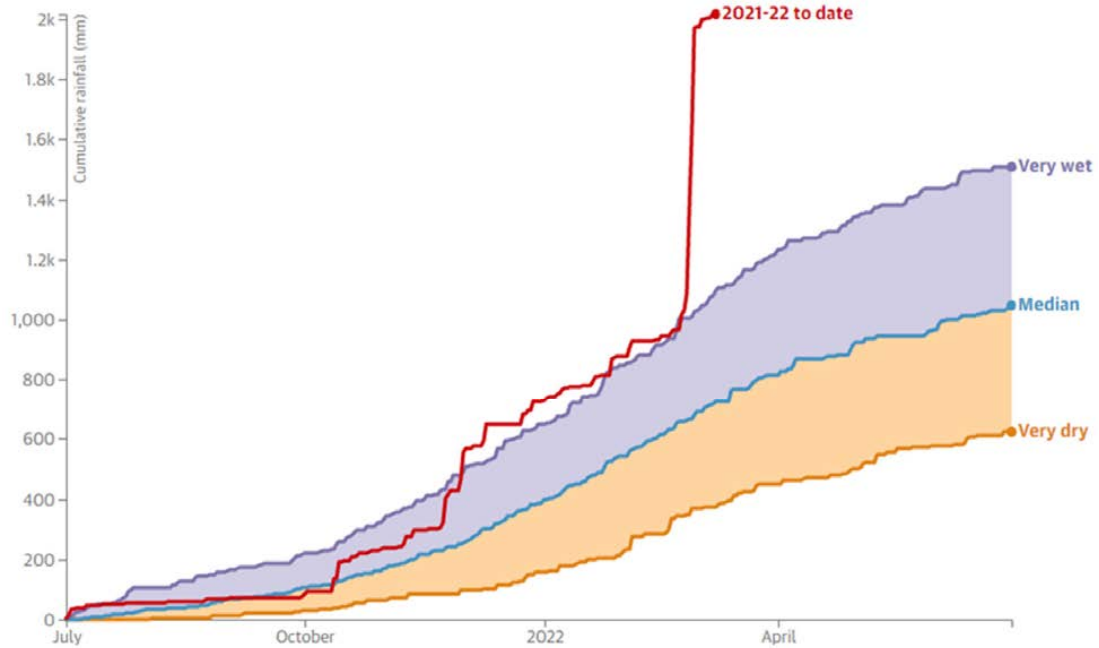
Figure 1: Brisbane cumulative rainfall vs. long-term averages to 08/03/2022 (Evershed and Nicholas, 2022).

As shown in Figure 1, the cumulative rainfall exceeded the 90th percentile at the Alderley rain gauge. East Coast Lows (ECLs) coming out of southeast Queensland have a profound effect on north-eastern NSW catchments, due to their size and proximity to southeast Queensland just across the border. As ECLs have a natural tendency to move in a southerly direction, the northern extents of the Clarence River, Richmond/Wilsons River, Tweed River and the smaller Brunswick River and Marshalls Creek catchments are collecting large volumes of precipitation prior to an ECLs reaching major north-eastern NSW towns (Figure 3).

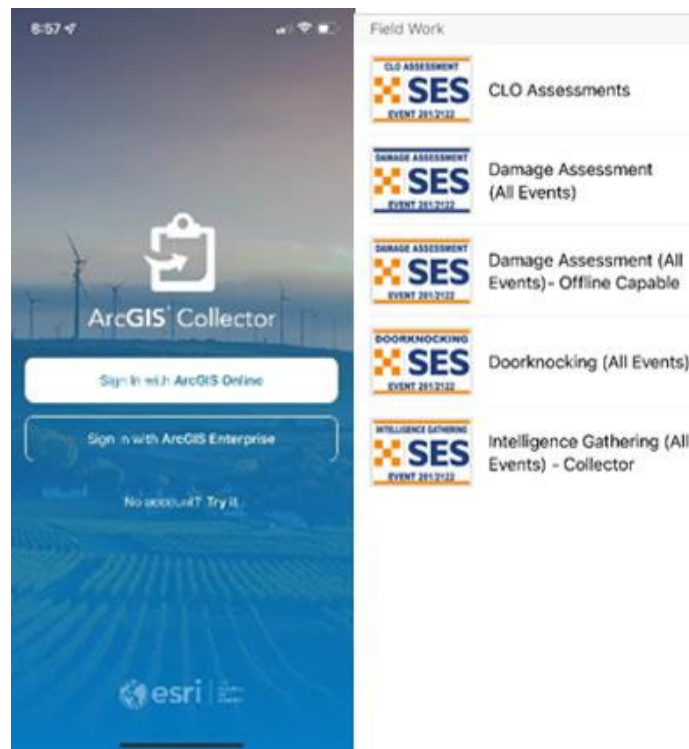
Figure 7: ArcGIS Collector app and SES intelligence/assessment maps.

The SES Operations Order directed the use of, and supplied instruction of, the ArcGIS Collector app (Esri, 2023) for all intel capture. SES provided a project-specific login and password for access to their intelligence gathering maps that allow real-time ingestion into their statewide mapping and intelligence gathering systems. Part of the Esri Geospatial Cloud, ArcGIS Collector (now migrating to ArcGIS Field Maps), is a mobile data collection app that makes it easy to capture accurate data and return it to the office by using web maps on mobile devices to capture and edit data. ArcGIS Collector works even when disconnected from the internet and integrates seamlessly into ArcGIS.

The Intelligence Gathering (All Events) – Collector map was utilised for this project, one of several in a suite of maps utilised for various intelligence gathering activities by SES or by organisations gathering information on behalf of SES (Figure 7). For example, the Australian Army utilised the Damage Assessment map within the ArcGIS Collector app for building assessments of flood-affected, damaged or non-inhabitable housing post flood in Lismore.

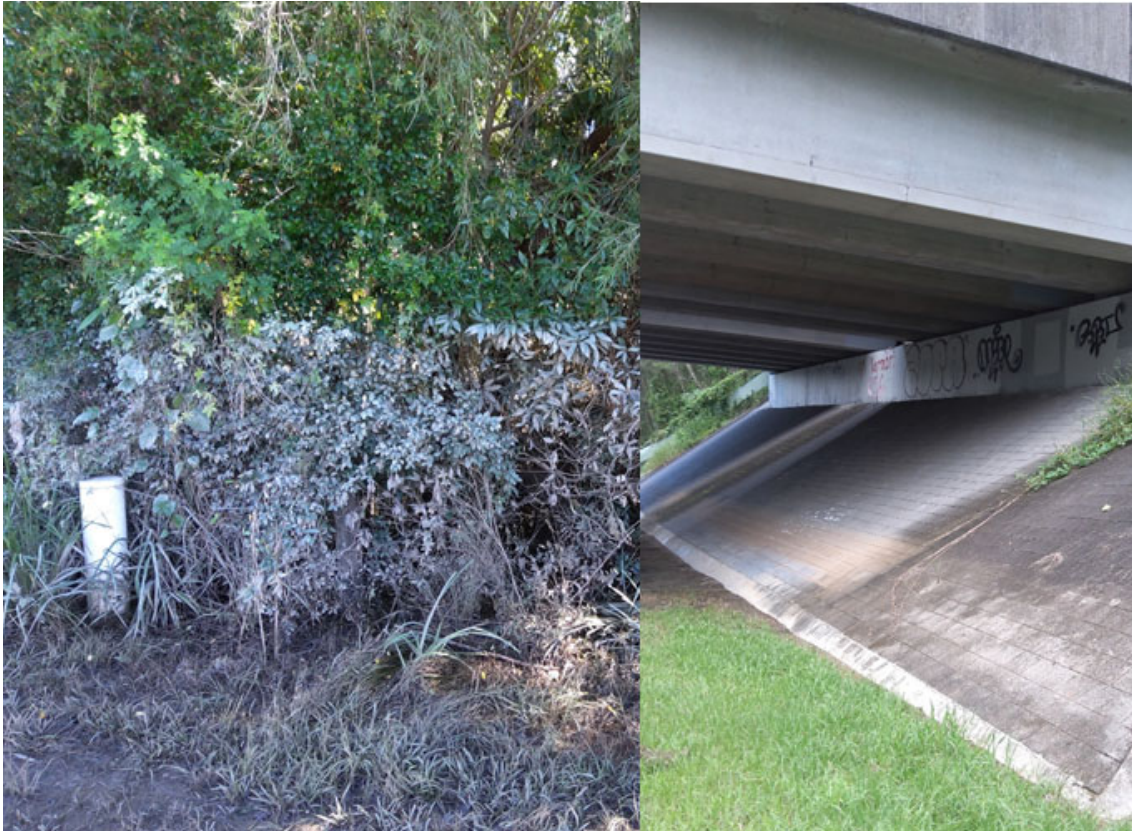
Figure 14: Silt line on vegetation and structures.

All PWL evidence surveyed needed to be definitive and ‘trusted’ (Table 2). Physical evidence was one source of evidence captured. SOR surveyors worked as one main team, therefore sometimes capturing points was quick and simple. However, often it was a time-consuming process, making contact, talking to residents, accessing their properties, identifying and confirming reliable evidence, or having access and offset locations that were difficult to take a ‘quality’ RTK shot at. Many PWL points had been marked up by residents, volunteers and workers, physically marking a surface (e.g. building, structure or road) with paint or Texta. Examples of various physical evidence are shown in Figures 14-23.

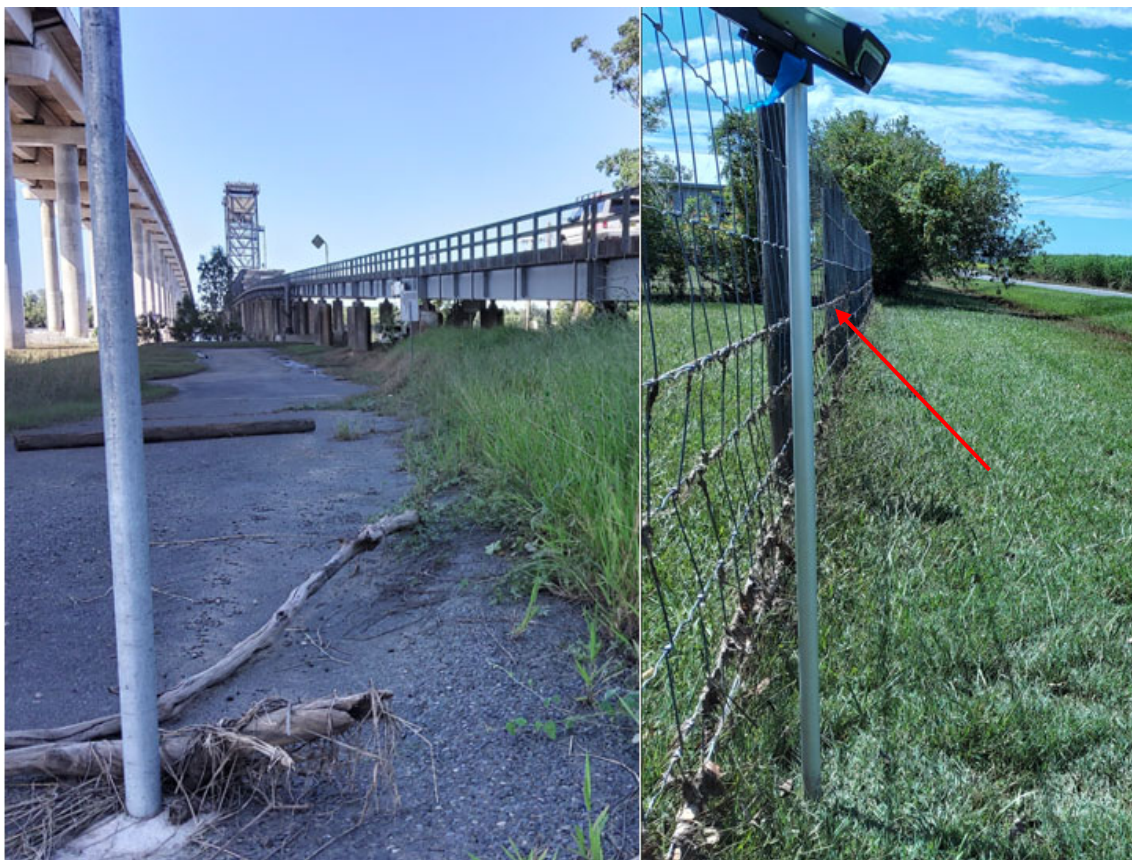
Figure 15: Large debris remains near rivers.

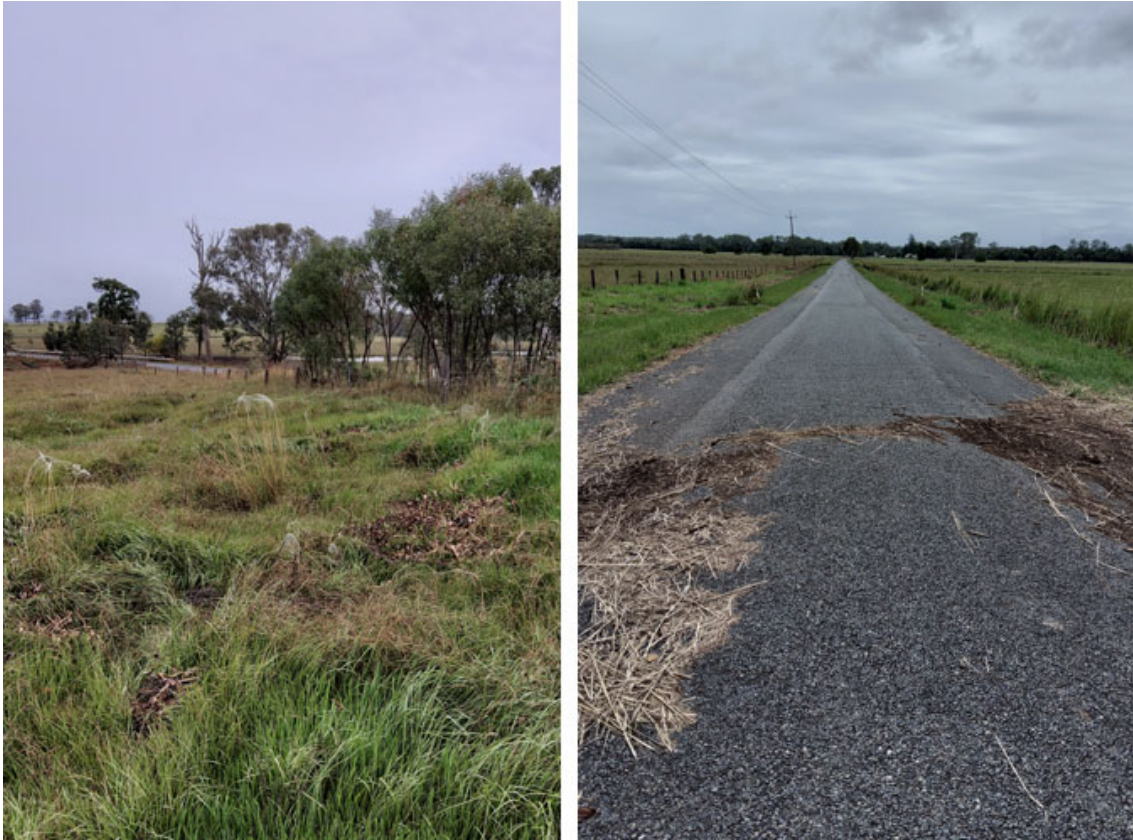
Figure 16: Debris on the road and in paddocks (edge of large area flooding).

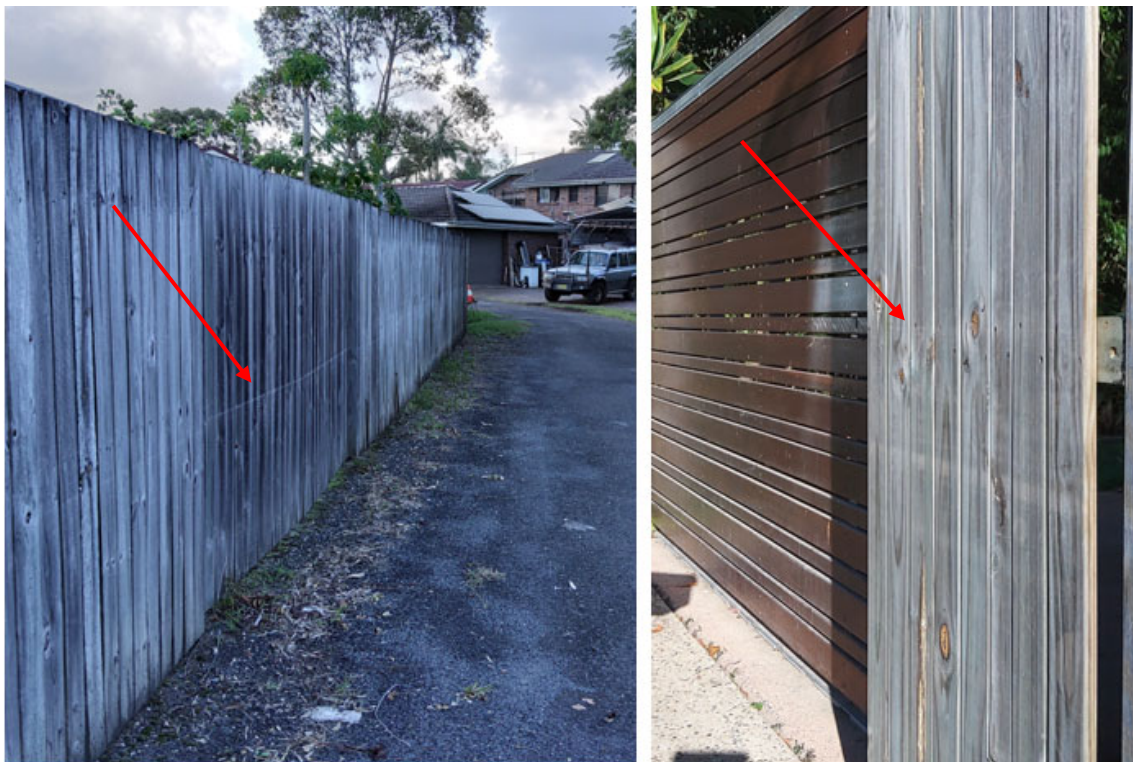
Figure 17: Scouring caused by debris moving past a structure.

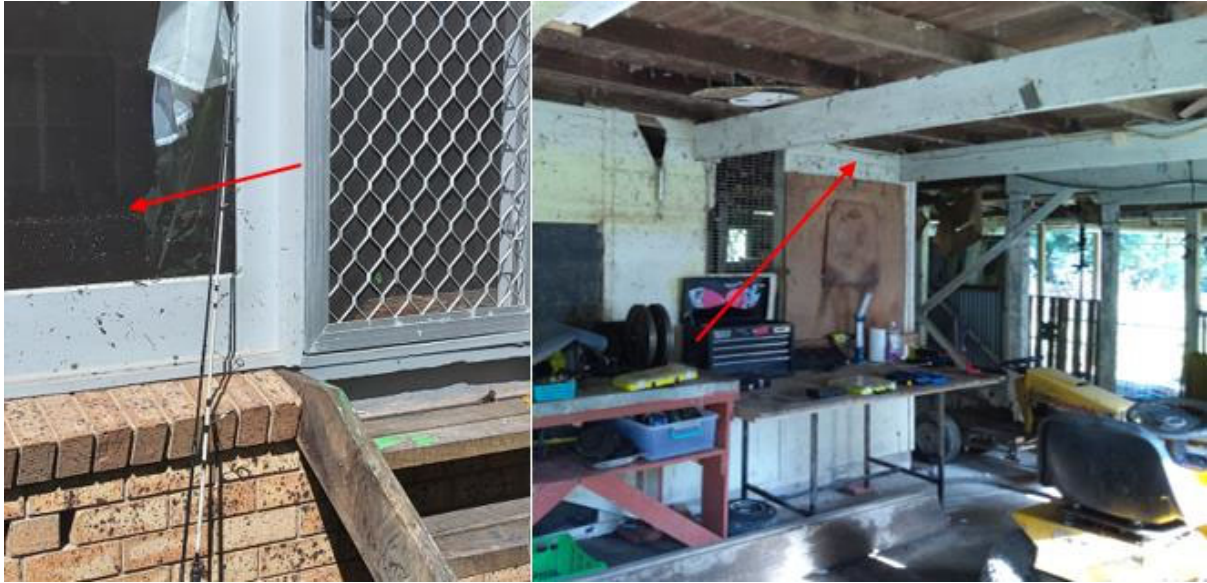
Figure 18: Small debris requiring horizontal offsets.

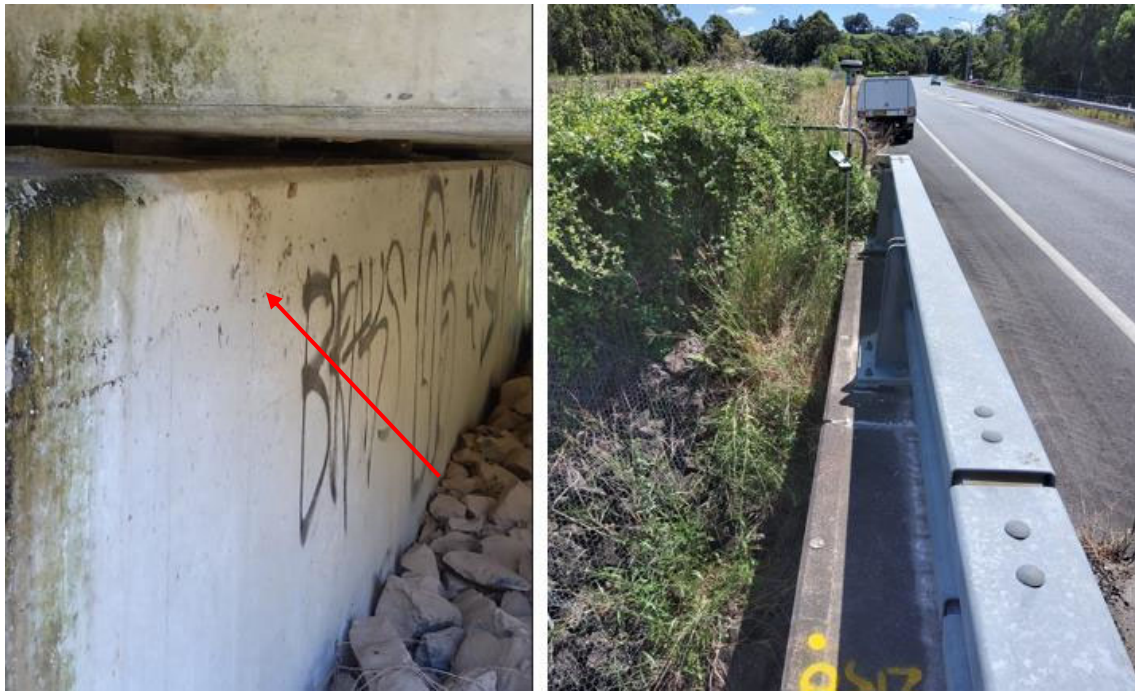
Figure 19: Debris on underside of bridge structures, requiring vertical offsets.

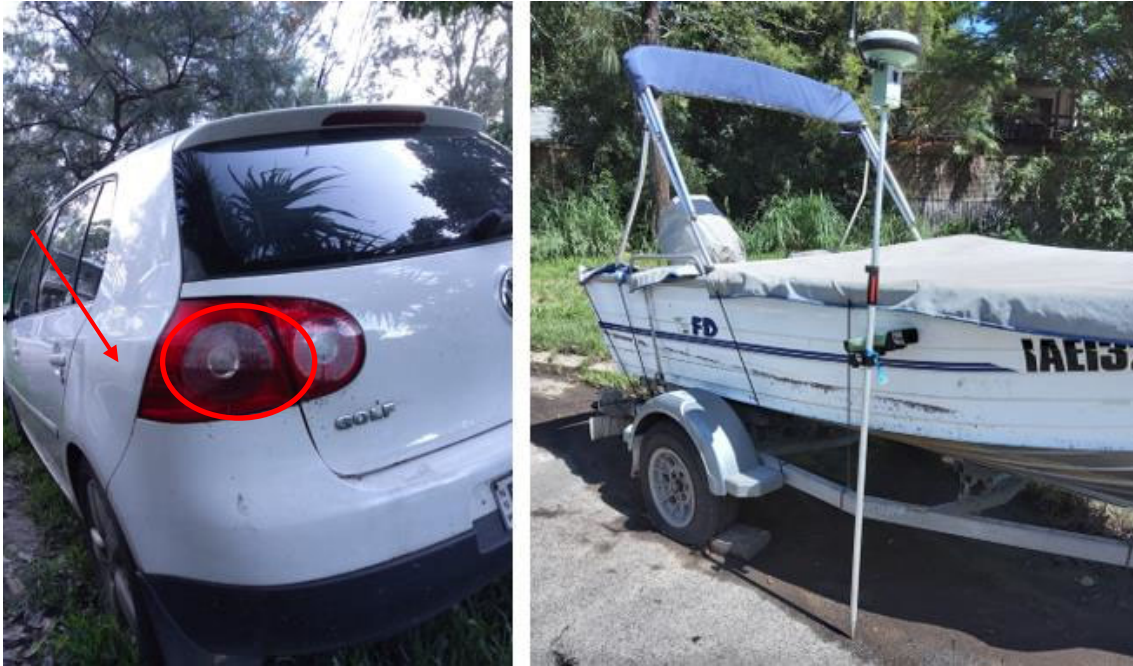
Figure 20: Light debris remains on motorised vehicles.

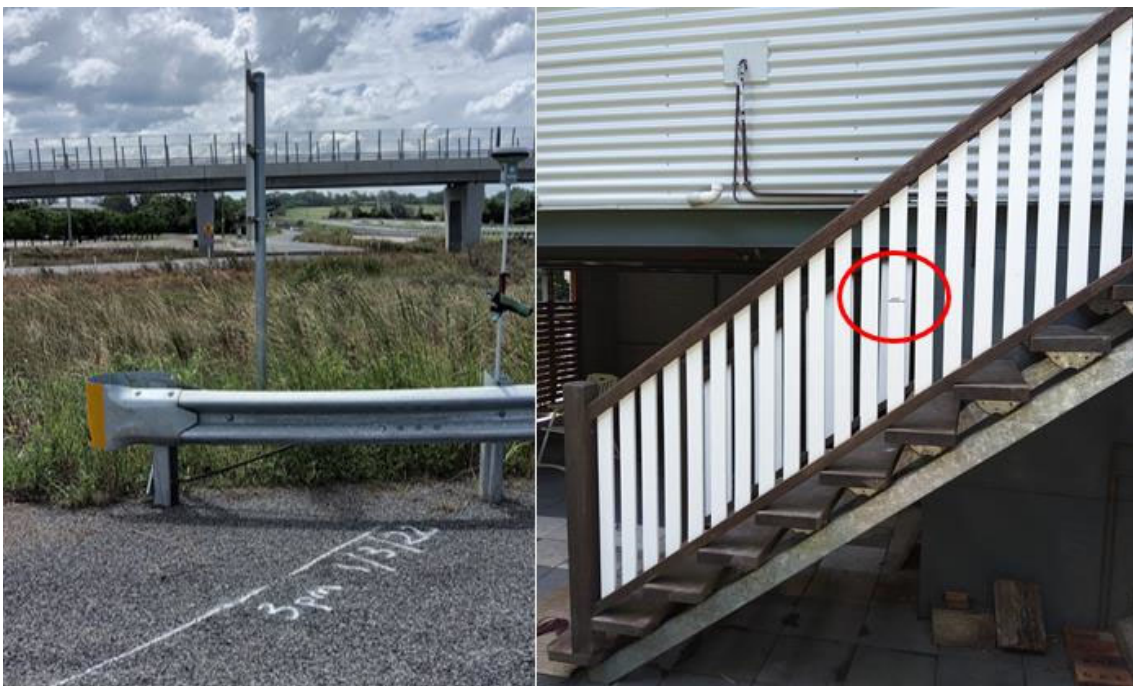
Figure 21: Marking provided by residents, volunteers and/or workers.

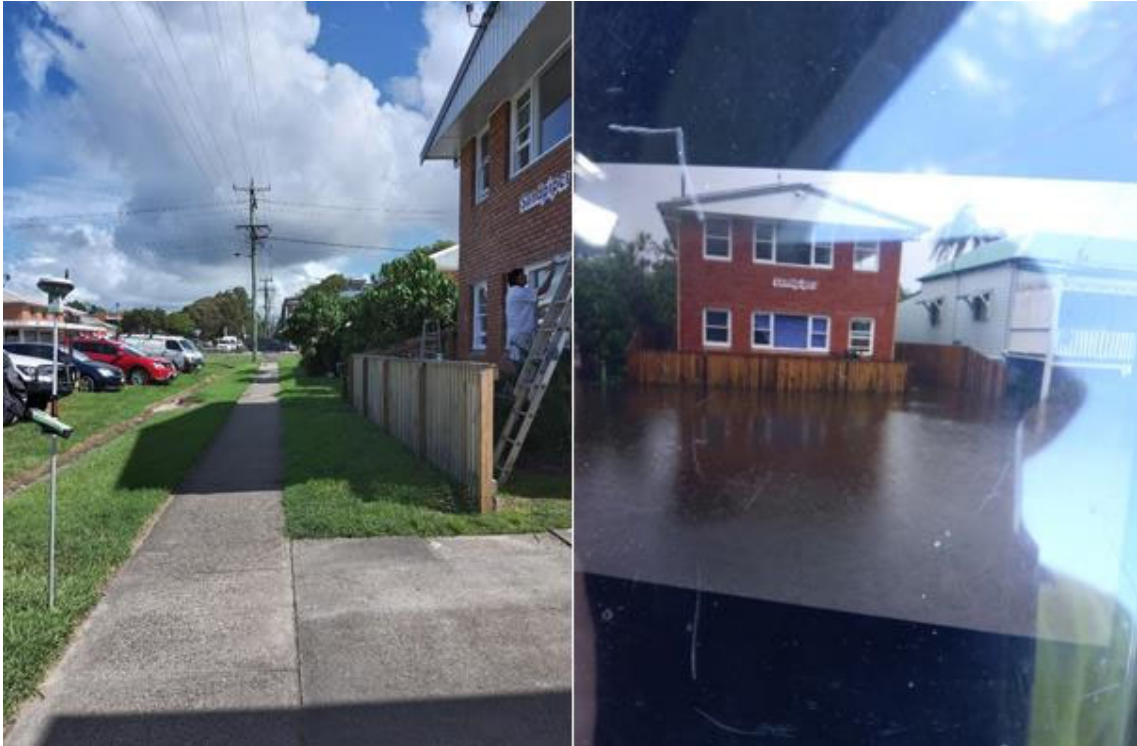
Figure 22: Photographic PWL evidence captured by resident (time/date captured).

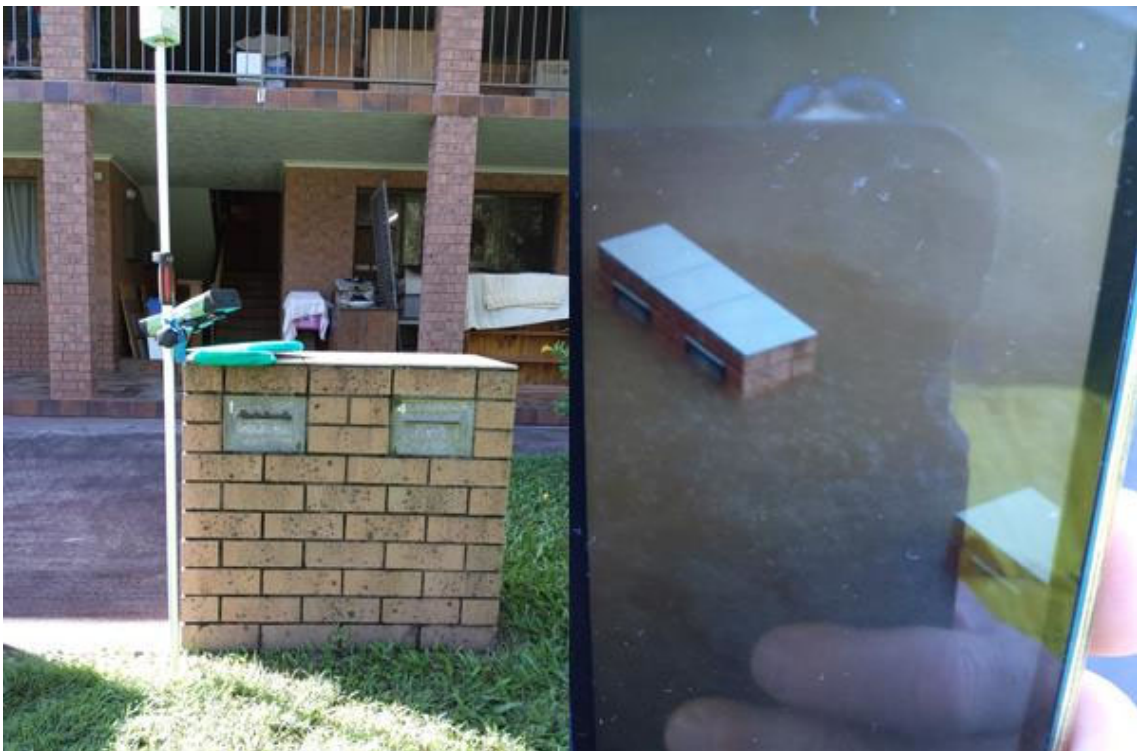
Figure 23: Photographic PWL evidence captured by resident (time/date captured).
